Quickly and Easily Solve Old-Style "Pop-Up" Drain Problems with the Advanced DrainKing™ from Fisher.

**ENJOY LESS STRAIN FROM YOUR DRAIN,
WITH THE DRAINING™**

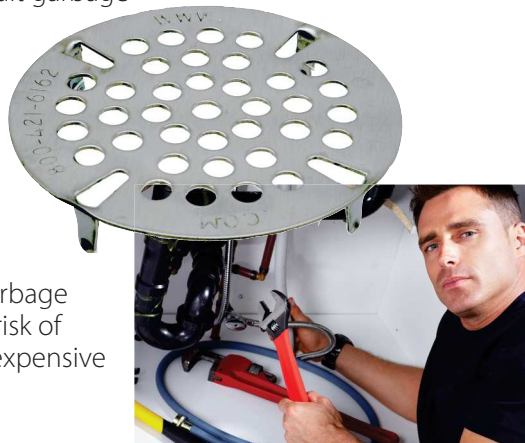
The damaged "O" ring will cause the pop-up drain to leak and the sink will be unable to hold water. This effectively stops the proper THREE step cleaning process as required by the Health Department - "Wash... Rinse... Sanitize".

Pop-up drains typically feature an unsecured strainer that over time can become misplaced or lost. As a result garbage will collect around the pop-up mechanism and clog its operation.

Now, the operator will typically use a utensil to push the garbage through the blockage, damaging the frail "O" ring that seals the poorly designed pop-up drain.

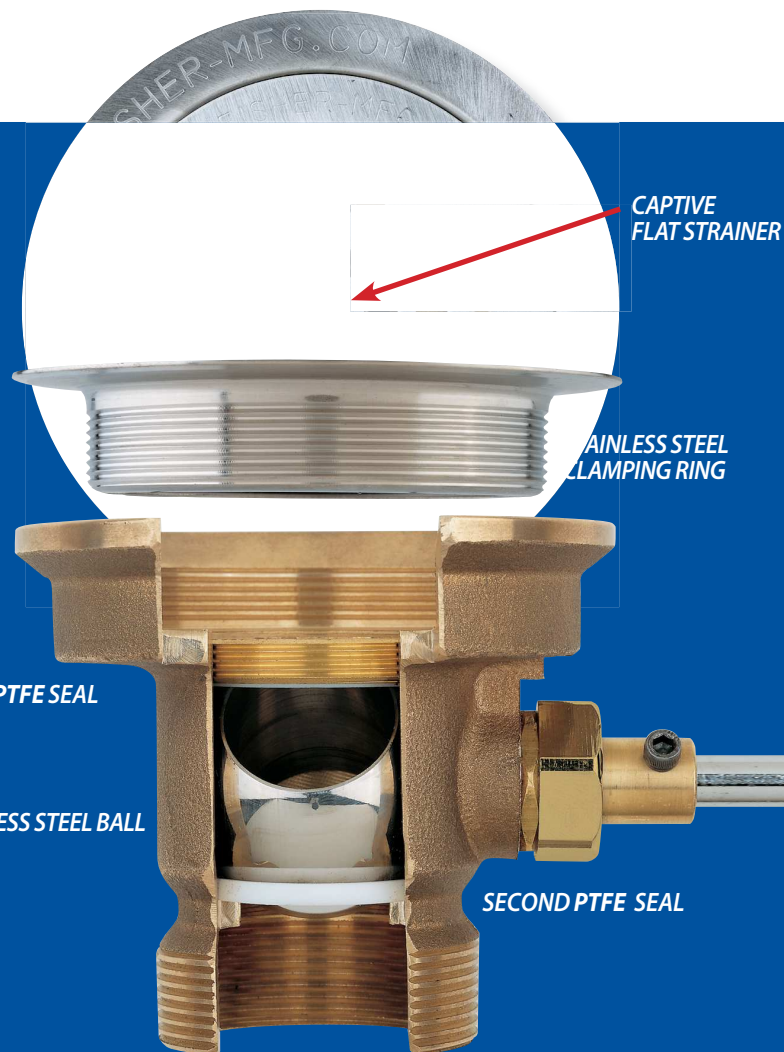
POP-UP DRAIN PROBLEM	DRAINING SOLUTION
Unsecured strainer becomes lost or misplaced	Vandal-resistant flat strainer is locked in place
Garbage builds around drain at bottom of sink	Strainer keeps debris clear; No Cam mechanism to further obstruct opening
Garbage is forced through drain with utensil damaging "O" Ring	Stainless Steel Rotary Ball with No "O" Rings
Drain Leaks; Sink won't hold water	Dual PTFE Seals ensure against leaking

- It's a "Ball Valve" for your sink!
- Stainless Steel Rotary Ball – not a "pop-up"
- 1/4 Turn Fully Opens and Closes Valve
- Clear-Through Opening – no need to disassemble for snaking
- Extra Sturdy Stainless Steel Clamping Ring – industry standard sealing angle
- Solid "Red" Brass Body – provides long service life
- 2" NPT Male / 1-1/2" NPT Female Connections – no adapters required
